Union Park Complex Restoration
Cottonwood Heights, Utah

September 2016

The Union Park Complex restoration project was completed in multiple phases over a 3 year period which included replacement of expansion joints, repairs to post tension cables, installing a traffic bearing membrane to approx. 150,000 sq. ft. of concrete surface at UP5 and UP6. The final phase of the project was the repair and coating of 21,000 sq. ft. of the exterior facade on building UP6 and installation of new stairs in the UP6 parking structure.

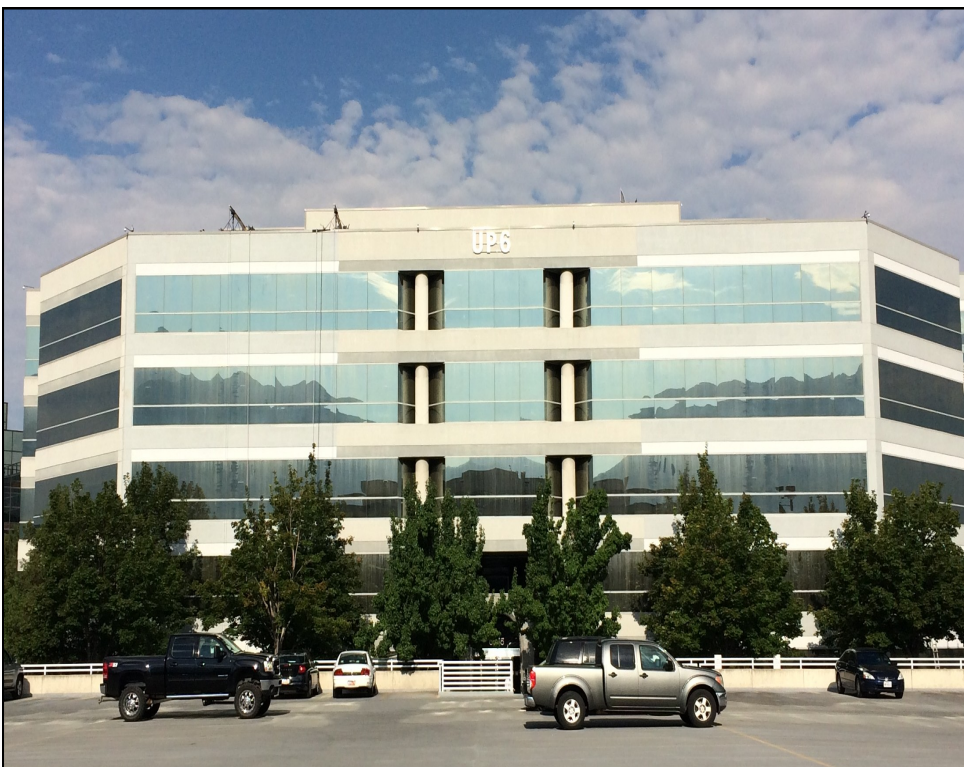
UP6 building showing the contrast in appearance before middle section of facade was completed.

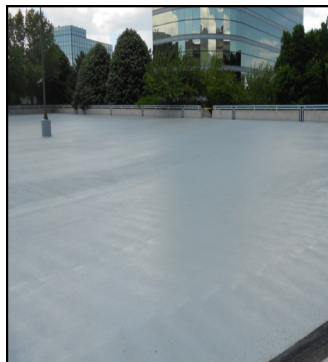
Traffic bearing deck coating
prior to striping

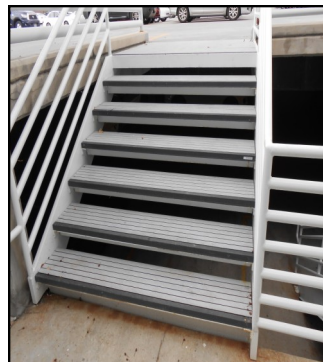
Installation of new stairs

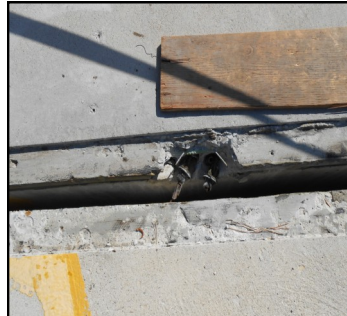
Broken Post Tension Cables

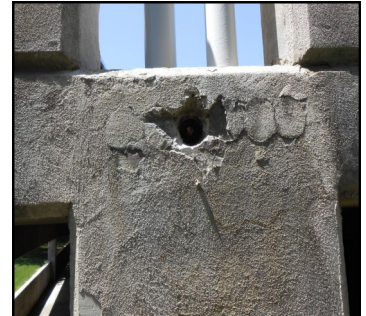
Evidence of Broken PT Cable
