# PROJECT PROFILE

Taylor's Landing  
West Valley, Utah

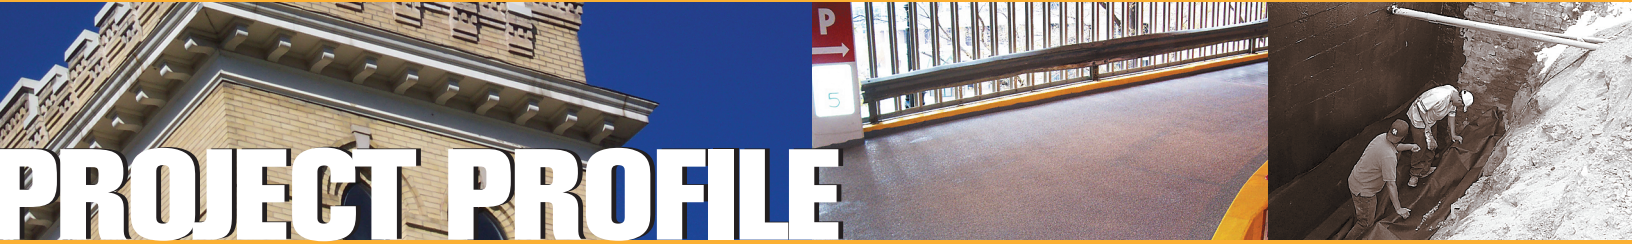
Ground water was leaking into the office and retail spaces located below grade.

**TOP:** Excavated foundation. **CENTER:** Failed mortar joints. **BOTTOM:** Backfilling waterproofed wall.

CRS excavated the problem area, cleaned the substrate, installed drain tile with a sump pump and catch basin, and applied a liquid waterproofing. After installing the protection board and back fill, CRS reset the grade, sloping the earth away from the building.
