China Bridge Parking Structure Repair

Fall of 2010
and
Spring of 2011

Park City Municipal Corporation
Swede Alley
Park City, Utah

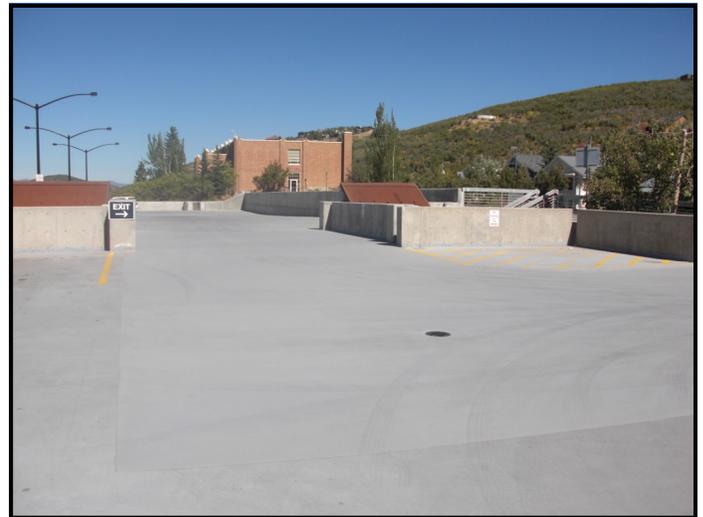
Above: Photo shows completed upper level of parking structure.

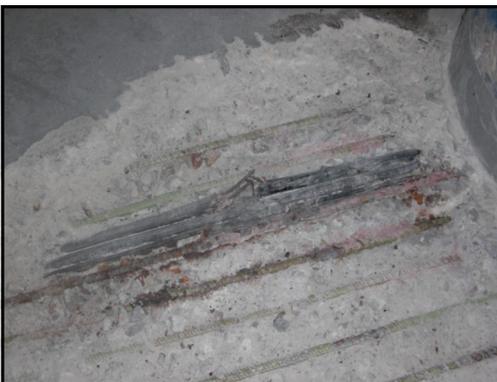
Exposed broken post-tension cable located at concrete de-lamination.

CRS was awarded the contract to repair the China Bridge multilevel parking structure. This project consisted of the repair of post tension cables, replacement of the expansion joints, repairs to concrete columns, delaminated post-tension slabs and parapet walls.

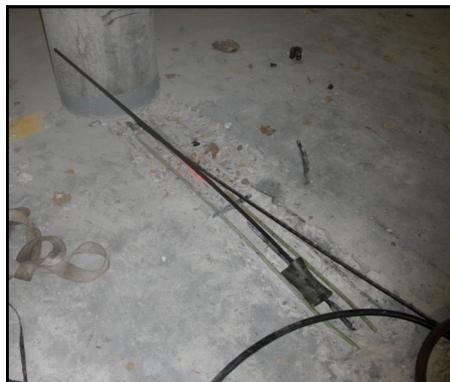
Repair of post-tensioned cable.

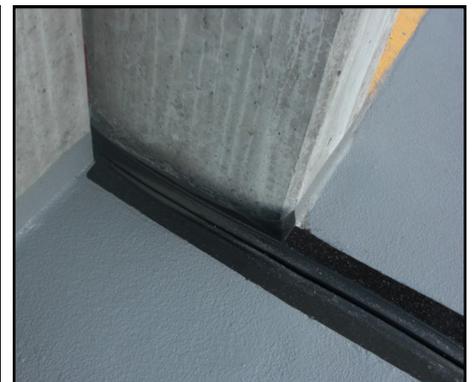
Detail of newly installed expansion joint.
