PROJECT PROFILE

The Weber Center
Ogden, Utah

The Weber Center is an office tower with below-grade office space.

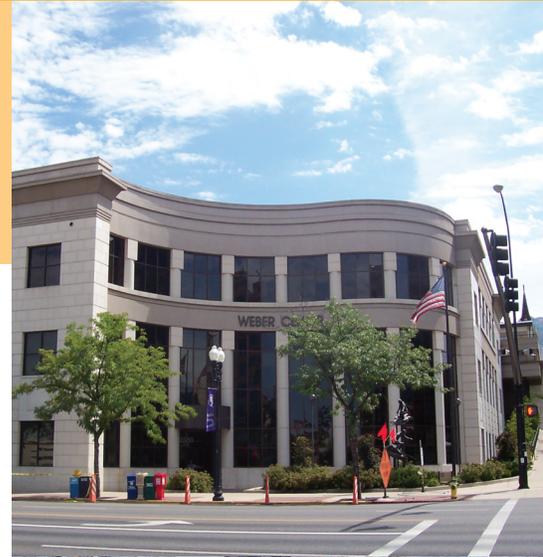
Water was leaking from the pedestrian area thru the ceiling into the facility's below-grade office space.

TOP: The Weber Center. **CENTER:** Void in structural slab that allowed water to leak into the offices below.
BOTTOM: Waterproofing installation in process.

To fix the leaky areas, CRS removed the sidewalk and failed waterproofing, cleaned the substrate, repaired the voids in the structural concrete, and installed new waterproofing. The repair area was flood tested for water leaks prior to the installation of the new concrete sidewalk. CRS worked with the UDOT, the UTA, and the City of Ogden to manage the traffic control aspects of this project.
