PROJECT PROFILE

Oquirrh School
Salt Lake City

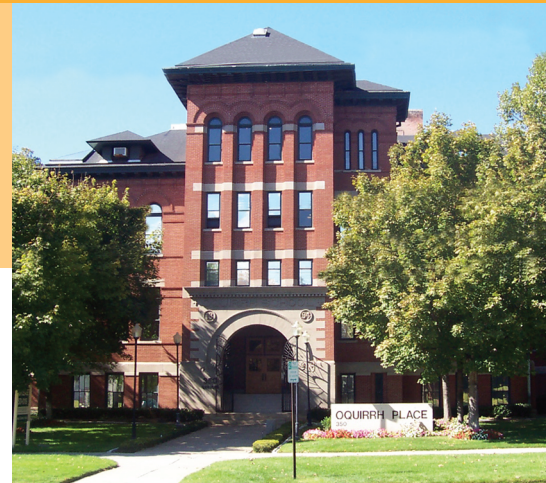
The Oquirrh School's exterior had missing mortar, movement cracks in the bricks, and failed caulking around the window frames. Additionally, the porous nature of the brick was allowing a great deal of water to penetrate and saturate the concealed surfaces of the brick causing staining and deterioration.

TOP: The completed project. **CENTER:** Efflorescence staining. **BOTTOM:** Failed mortar joints.

CRS removed and replaced failed and missing mortar, routed and caulked the movement cracks, removed and replaced the failed caulking, and cleaned and sealed the exterior brick.
